# Home Inspection Report

108 Springhaven Dr  
Oak Grove, USA 12345

**Patrick Nash**  
**Patrick Nash Home Inspection**  
email@sample.com  
(123)456-7890

September 23, 2014

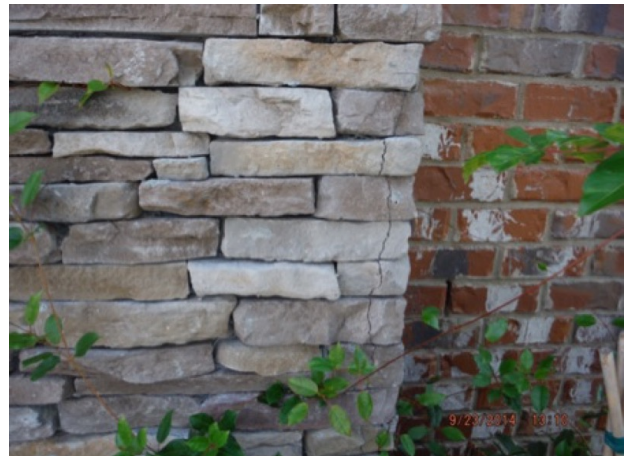
- ☐ Narrow cracks in faux stone veneer at front of garage.

*Vertical cracks in stone*

**Narrow cracks in faux stone veneer at front of garage.**

- Monitor.

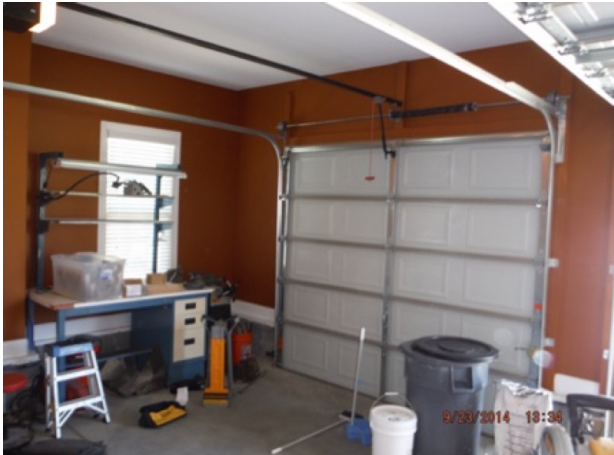
- ☐ Front garage door does not reverse on contact with obstruction

*Front garage overhead door*

- Safety Concern

**Front garage door does not reverse on contact with obstruction**

- Adjust downforce safety reversing setting on automatic door motor.

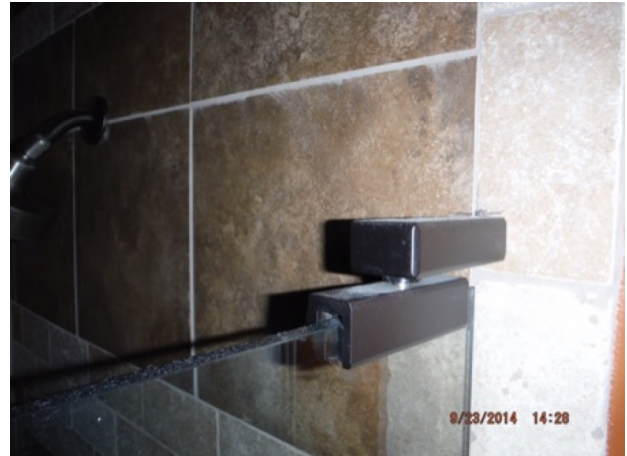
- ☐ Master shower door does not center in closed position properly.

*Shower door top hinge*

**Master shower door does not center in closed position properly.**

- Adjust or replace centering hinge(s)

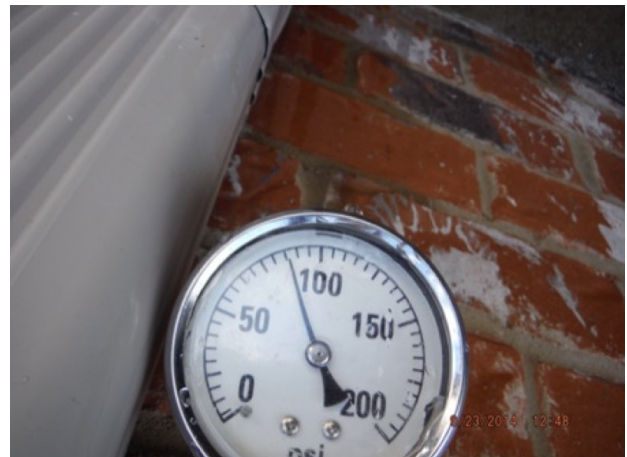
- ☐ Water supply pressure is slightly above the maximum recommended pressure of 80 p.s.i.

*Water pressure is higher than 80 p.s.i.*

**Water supply pressure is slightly above the maximum recommended pressure of 80 p.s.i.**

- Adjust pressure regulator to 80 p.s.i. or lower. Regulator is located in front landscape bed.

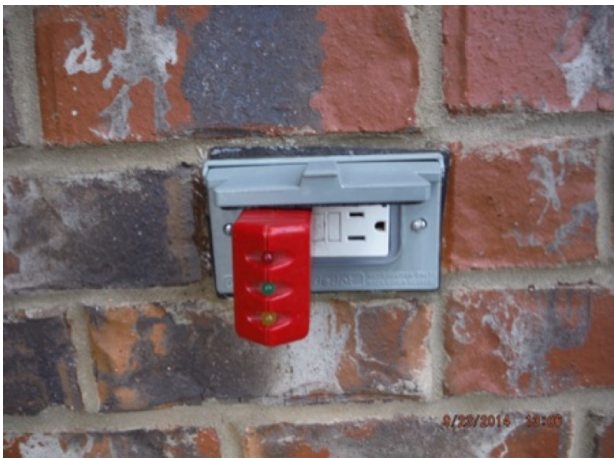
- ☐ Dead GFCI receptacle front porch

*No power at front porch GFCI receptacle*

#### Dead GFCI receptacle front porch

- ▶ Repair dead receptacle. Further investigation is needed, as receptacle may be defective, or possibly fed through an inaccessible GFCI that is tripped off.

- Repair dead receptacle. Further investigation is needed, as receptacle may be defective, or possibly fed through an inaccessible GFCI that is tripped off.

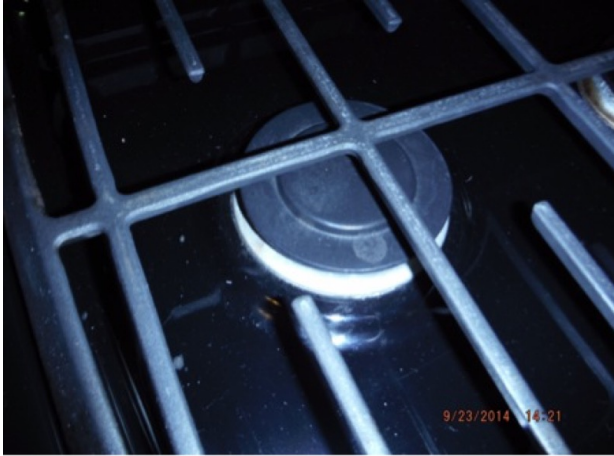
□ Right front burner flame goes out when control knob is turned to "low"

*Right front burner*

► Safety Item

#### Right front burner flame goes out when control knob is turned to "low"

- Adjust burner to stay on when knob is set to "low" setting
